Sharing lessons learned

VIRP Digest is a quarterly e-bulletin, sharing 'lessons learned' from maritime accidents, incidents, and near-misses uploaded by HELMEPA member-vessels to the Voluntary Incident Reporting Platform (VIRP).

Complying with Pilot Ladder Regulations

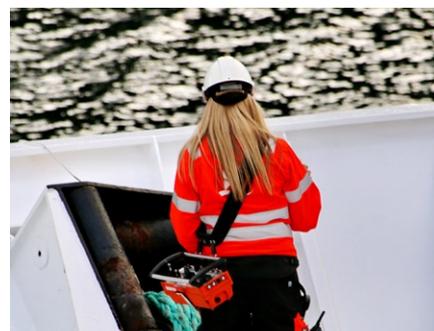
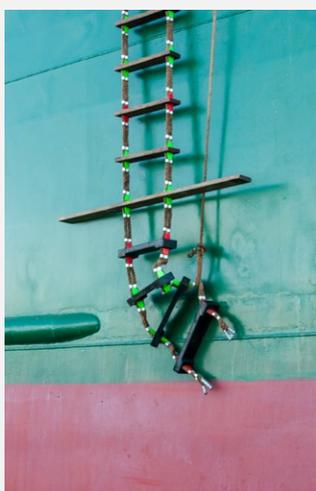
While a cape size bulk carrier was at Las Palmas anchorage (March 2022) and crew change was underway, a sign-on female Deck Cadet nearly fell from the pilot ladder during her embarkation under moderate weather conditions. The vessel has 6.7m freeboard and the female Deck Cadet was the first to embark the vessel using port side pilot ladder. She grabbed the ladder and started to climb, yet she couldn't continue.

A **risk assessment** for safe transfer of people by pilot ladder should be part of each vessel's Safety Management System.

When considering the risk of use of a pilot ladder for transfer, as a minimum, attention should be given to:

- The experience and capability of people using the pilot ladder
- The physical demands of using a pilot ladder, especially in the case of female seafarers and visitors
- Sea state and weather conditions i.e. boarding side should be protected from the weather
- The ability of a launch or other vessel to act as a platform to safely transfer people to or from a pilot ladder
- Measures to prevent falls
- Emergency response if a person using the pilot ladder falls
- Use of other means of transfer which present a lower risk under circumstances

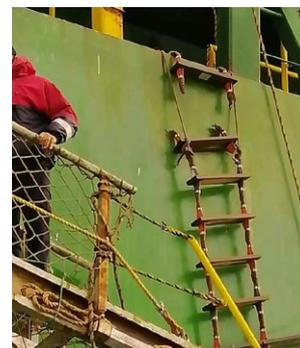
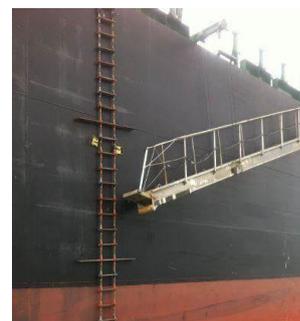
Post-incident reports often detect poor condition of side ropes, that a routine visual inspection would have easily detected. Prior and after use the pilot ladder must be inspected to identify any damage done. Pilot ladders should be less than 30 months old – the year of assembly or reassembly can be found on ID plate usually located on lower spreader.

Incidents often include inappropriate rigging arrangements i.e. the use of shackles or ladders attached to guardrails. Pilot ladders should be secured to deck strong points by a rope stopper lashed to the ladder's side ropes. Steps should be horizontal and evenly spaced, clean and in good overall condition.

The pilot ladder should be in good condition and regularly inspected

The pilot ladder should be safely rigged

When not in use, the pilot ladder needs to be covered to avoid exposure to contaminants or other elements that may cause degradation and failure.
