DIGEST issue 4, Nov. 2023

# SAFETY LESSONS

## Collisions Averted: The Importance of Bridge Team - Pilot Communication

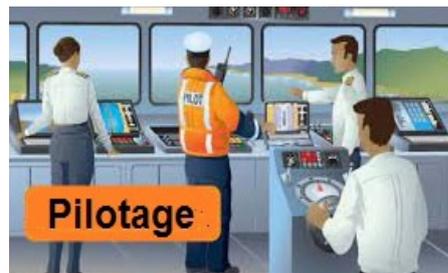
## INCIDENT 1

During daylight, with good weather but poor visibility, a container vessel, under pilotage while transiting the channel outbound, collided with an inbound transiting bulk carrier, which was also under pilotage.

During the Master-Pilot exchange the expected inbound traffic had been discussed. Accordingly, the pilot confirmed that there should be only one inbound vessel, and there is an agreement with the pilot of the other vessel to pass Green to Green due to container's deep draft to keep close to green buoys, where there is greater depth.

The Master notified the Pilot that the inbound vessel was not allowing enough space by not keeping to his left side of the channel. The Pilot contacted the other vessel pilot on VHF channel 12 talking in their own language and confirmed that all was in good order and the vessel would pass Green to Green.

The Chief Officer notified the Master that the other vessel's intentions were not clear, turning to her starboard. The Master notified the pilot accordingly and asked the forecastle lookout to report if the other vessel was visible and in which position. The lookout responded that the other vessel was not visible yet.

Due to the risk of collision, the forecastle lookout was instructed to leave their duties and to proceed to safe area. After having a look at the radar screen, the Pilot realized the risk of collision was high. Therefore, to prevent collision, he instructed hard to port to keep the agreement for passing Green to Green.

About 2 minutes later the two vessels collided.
