DIGEST issue 4, Nov. 2023

# SAFETY LESSONS

## Collisions Averted: The Importance of Bridge Team - Pilot Communication

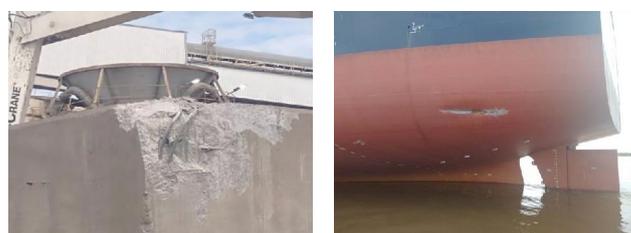
The vessel's headway was stopped, and the main engine was set on 'slow astern' to move her parallel to the berth, but due to the current (between one to two knots), the stern turned to port towards the berth. Due to this fact, the pilot advised 'slow ahead' to stop said turn.

About 2 minutes later, the pilot advised 'half ahead', then 'full ahead' and rudder hard to starboard, in order to reduce the speed and keep the stern away from the berth. In spite of this, the vessel continued drifting towards the berth.

About a minute later, the vessel's port quarter contacted the upriver mooring dolphin. Consequently, the vessel and the dolphin sustained damages.
